Damage Degrees of Historical Buildings After the Conflict in Diyarbakır Sur District

Research Article / Received: April 18th 2024, Revised: May 23rd 2024, Accepted: May 28th 2024

Refer: Sipahi, S., Bural, Z., (2024), Damage Degrees of Historical Buildings After the Conflict in Diyarbakır Sur District, Journal of Design Studio, V.6, N.1, pp 47-56.

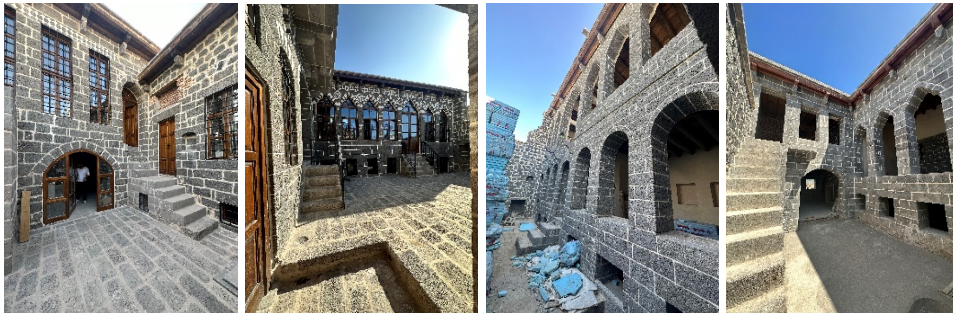
According to the created map, it can be observed that in the eastern part of the Sur district, there is a concentration of buildings that have been restored or are undergoing restoration, along with some lost structures. It has been determined that these lost structures have been removed from registration and converted into streets. The eastern region encompasses the neighborhoods where the conflicts occurred, and it is observed that most of the damage occurred in this area, hence restoration efforts are ongoing here.

Figure 2: Examples of buildings that have been restored or are in the process of restoration

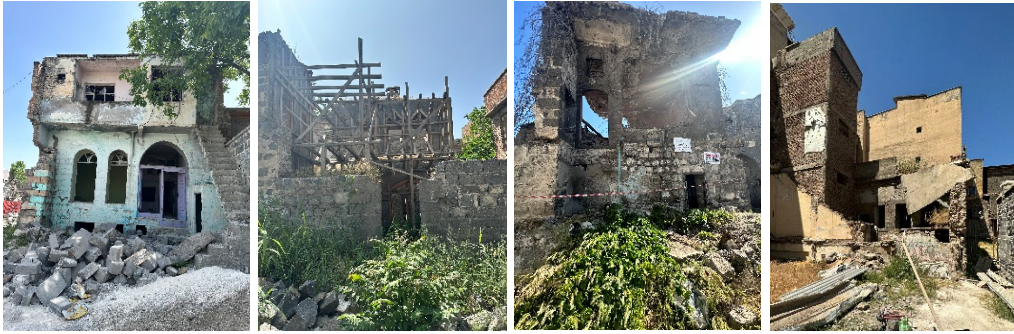
Figure 3: Severely damaged buildings

types. Out of the 9 severely damaged buildings, all are residential; out of the 5 moderately damaged buildings, 1 is a church and 4 are residential; out of the 4 slightly damaged buildings, all are residential; out of the 254

In addition to the restoration efforts initiated after the conflicts in the Inner City, some structures are still awaiting restoration, while others have not yet begun restoration work despite being damaged. It is imperative to commence restoration work on these structures awaiting restoration to eliminate the damage in the area as soon as possible.

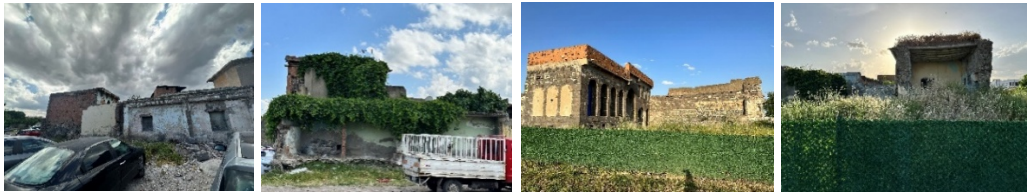
Figure 4: Buildings with minor and moderate damage

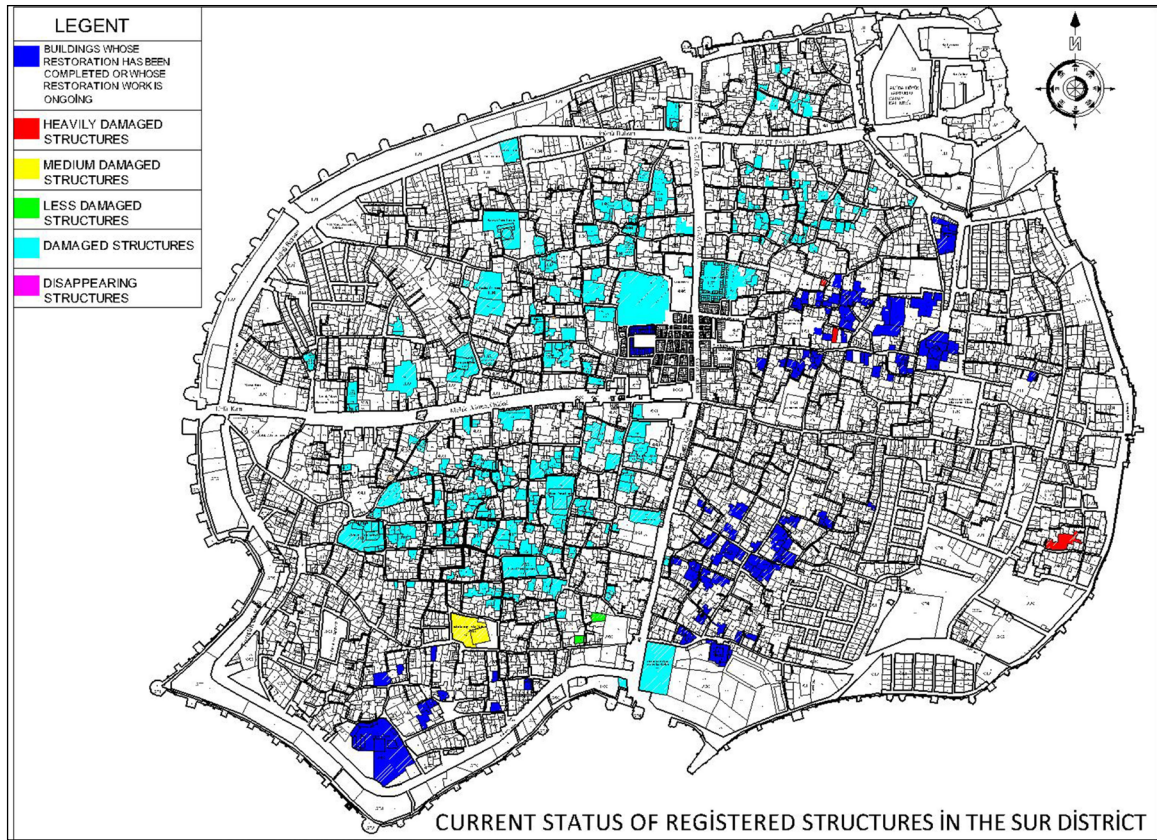
Figure 6: Damage degrees of registered buildings in the Inner City

Based on the data in Table 1, the current statuses of the structures on the zoning plan were processed to create a legend (Figure 6), and the areas in the Suriçi region that have been damaged were discussed.

After the conflicts in the Inner City, restoration work on historical buildings has begun. It has been found that damaged structures are more concentrated in the eastern part of the Inner City, where conflicts were most intense. The findings indicate that restoration work in the area has reduced the number of damaged structures. While some structures have completed restoration, others are still undergoing the process. Additionally, restoration has not yet begun on some damaged, slightly damaged, and moderately damaged structures. It is imperative to commence restoration work on these structures as soon as possible. The significant progress in restoring damaged structures in the Inner City after the conflicts is considered a positive approach towards preserving the historical environment. However, the extent to which these restoration efforts maintain the original character of the structures requires further investigation.

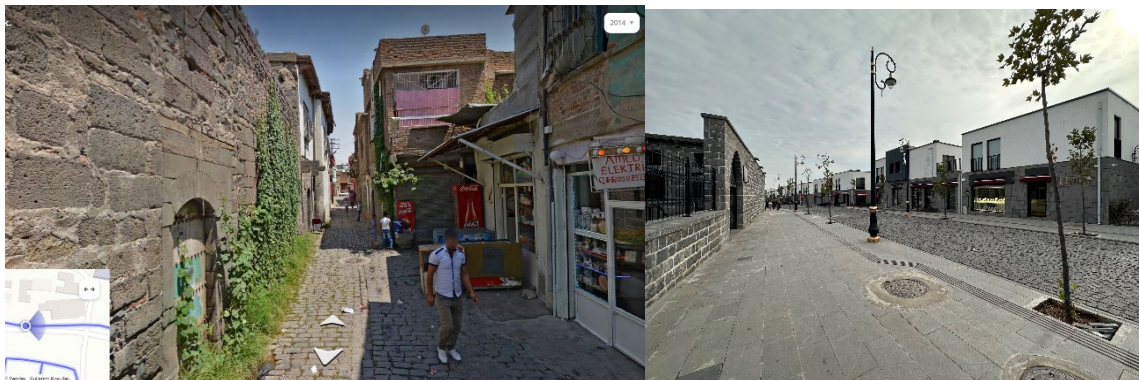
Figure 7: The left photograph shows the Yenikapı Street Yandex Maps 2014 image, while the right photograph shows the Yenikapı Avenue 2022 image.

Through on-site inspections, it has been determined that the street where three buildings were lost due to destruction has been transformed into a boulevard. It is observed that this boulevard is not compatible with the organic texture of the urban conservation area, indicating an application contrary to the urban fabric in this region. The wide boulevard constructed in contrast to the narrow alleyways of the Inner City disrupts the city's silhouette.

Out of the damaged structures, 204 have either completed restoration or are currently undergoing restoration. However, restoration has not yet been initiated for 18 damaged structures. It has been identified that some streets have been widened or transformed into boulevards as part of the restoration efforts. Upon examination of the boulevard, it was found that three buildings were delisted and lost, and three buildings were reduced in size due to their alignment with the road. However, it is observed that these three reduced buildings have been restored to their original state. Widened or boulevard-transformed streets disrupt the urban fabric and emphasize the importance of adhering to the original characteristics of these streets.
