An Analysis of the Architectural Properties of Eyüp Çeribaşı Masjid: Conservation Problems and Proposals

Abstract

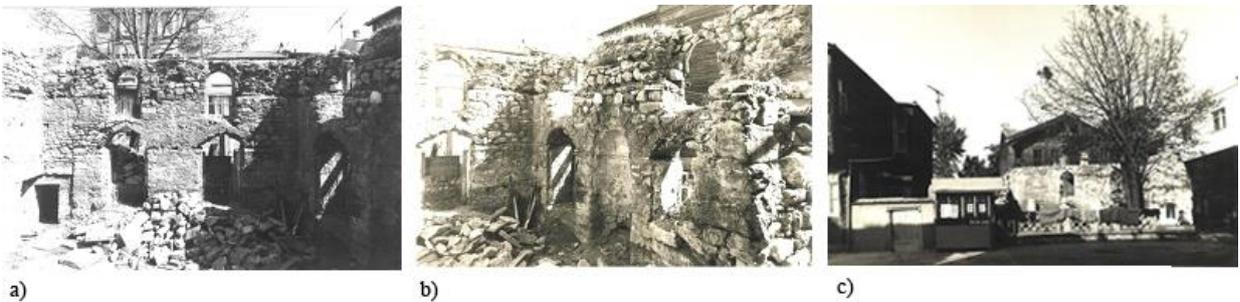
The archival photos dated 1956–1959 are the earliest visual information about the structure (Figure. 3). These photos show that there is no covering of the masjid; only the main walls are standing. Its minaret has also been demolished to the level of the base (kaide) (Figure. 3c). Although it is not known for what reason the masjid was damaged, it seems likely that this has been the result of earthquakes and fires, as is the case for many buildings in Istanbul. The abandoned structure must have entered a period of rapid deterioration following the demolition of the roof. In this process, elements such as the doors and windows have disappeared, the interior space was filled with rubble, and the building has become a ruin (Figure. 3a,b).

Figure 2. Çeribaşı Masjed; a, b) interior façades, the end of 1980's [27] c) the exterior western façade, 1956-59 [27]

As shown in Figure 3, the walls of the building were made of rubble stone from the inside and ashlar stone from the outside. The windows are tangent arches with brick on the inside and limestone on the outside (Figure. 3). The mihrab niche's arch was also made using brick. On the outside, the covered space that was next to the cemetery and surrounded by the iron joinery is today used as the ablution place. The cemetery boundaries were covered with the stone tracery (Figure. 3c).

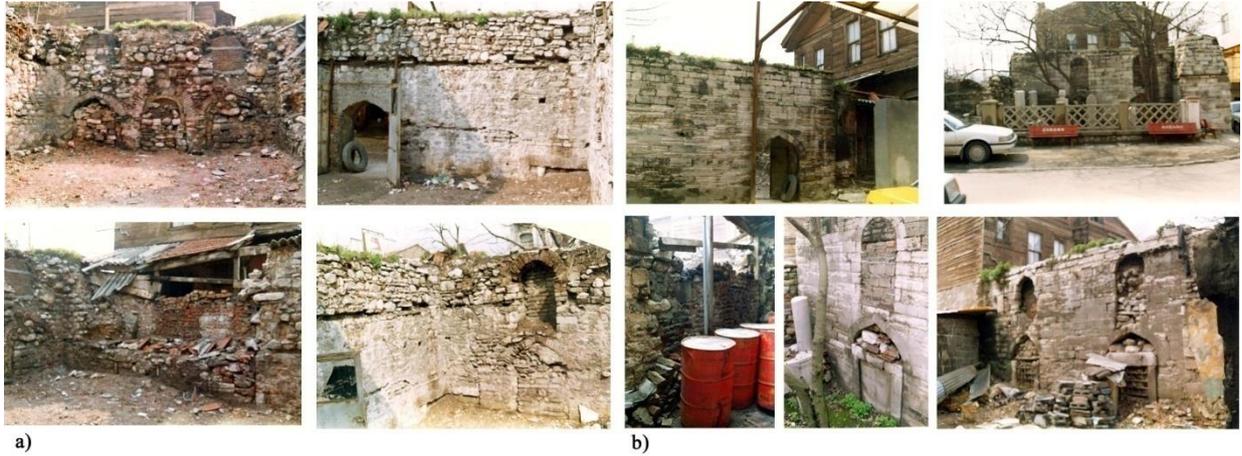
Figure 4. The photos attached to the survey report dated 1993; a) interior photos b) exterior photos [27, 29]

In the photos of an architectural survey made in 1993, the windows and mihrab niches are closed with rubble and brick fillings, unlike the condition in 1956–59 (Figure. 5). These fillings were likely added during the period that it was used as a storage facility by the gas station. The process of restoration begun with the approval of the restoration project by the No.I Istanbul Immovable Cultural and Natural Heritage Protection High Council with No. 9591 of 01.15.1977. Two years later, it was concluded with the No. 7072 of 04.21.1993 decision of the No.I Istanbul Immovable Cultural and Natural Heritage Protection High Council that the measurements of stone cornice and minaret were appropriate. However, it was decided to return the drawings of the lower parts of the balcony to the council, after re-examined according to the same period samples. In addition to the restoration project, the 1/50 scale eastern façade view of the masjid and

In the restoration report of the same date, it is stated that the filler soil at the inside and outside needed to be removed to reveal the original flooring level and material, so that the main door and minaret entrance of the building could be used. The ruined western wall should be completed and – except for the extremely damaged lintel, masonry, arch stones, and façade covering – façades should not be touched (Figures. 5a,b).

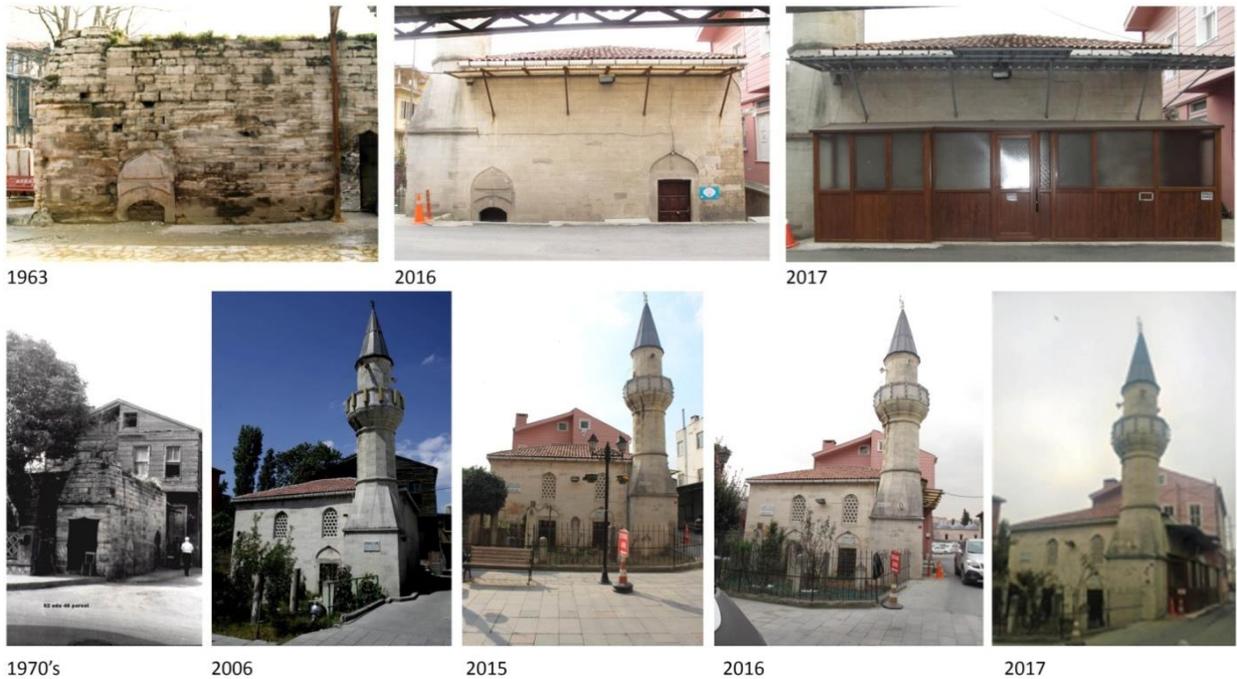
Figure 5. In the historical process, the change of the Çeribaşı Masjid entrance façade; (the photo in 1963 [27,29]; the photo in 1970's [29]; the photo in 2006 Ali İhsan Gülcü Archive [27]; the photos in 2015-2016 [27])

Figure 6 shows the changes to the Çeribaşı Masjîd throughout the historical process. The steps that reach two different entrances must have been added during the restoration phase. The metal-framed fringe, attached to the North façade, was added before 2015 and was renovated in 2017. In the same year, the plastic joinery part adjacent to the entrance wall was added (Fig. 6).

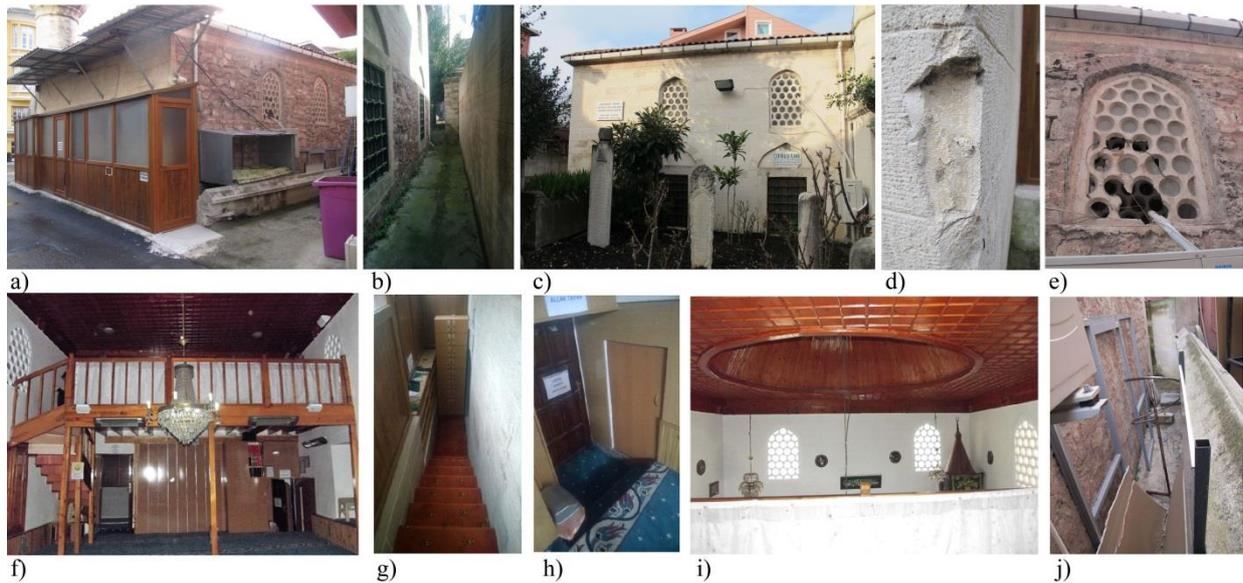
Figure 9. The interior and exterior photos of the Çeribaşı Masjid

The northern and eastern façades are exclusively in the appearance of the ashlar masonry, the western façade is the rubble masonry. The southern façade was built with the rubble masonry up to the level of the arches, while the upper part is in the appearance of the ashlar masonry (Figures. 10a,b). It has seen that during the repairs the original stone walls are covered with incompatible plaster about 2 cm thick and the joint marks are drawn on it (Figures. 10d). Also, the mortar between the rubble stones has been repaired with the cement mixture incompatible with the original material (Figures. 10a,e).

As a result of the rise of the roadway, the level between the road elevation and the eaves high has also decreased which has affected the appearance negatively because it has changed the proportions of the façade. Depending on the unqualified additions, the relationship with the environment of the masjid has broken and substantially lost the symbolic value of its entrance façade. The rain gutters surrounding the eaves and the downpipes are the other factors that negatively affect the appearance of the façades (Fig. 10a,c).

- The materials that are not properly made, such as the plastic joineries, doors, bite bars, and concrete windows should be renovated with similar period samples characteristics.
- Closing the door that has been used as the men's entrance and renovating it as a fountain, as it was originally.
- Removing the mortars that have been used for façade cladding and the joint filler that is incompatible with the authentic materials, and should be renovated with the original mortar (Figure. 11).
