## Problems Arising in Areas Where Urban and Archaeological Sites Coexist: The Case of Seyitgazi

Kentsel ve Arkeolojik Sit Alanlarının Bir Arada Bulunduğu Bölgelerde Ortaya Çıkan Sorunlar: Seyitgazi Örneği

Hatice ELMAS<sup>1</sup>, Özlem SAĞIROĞLU DEMİRCİ<sup>2</sup>

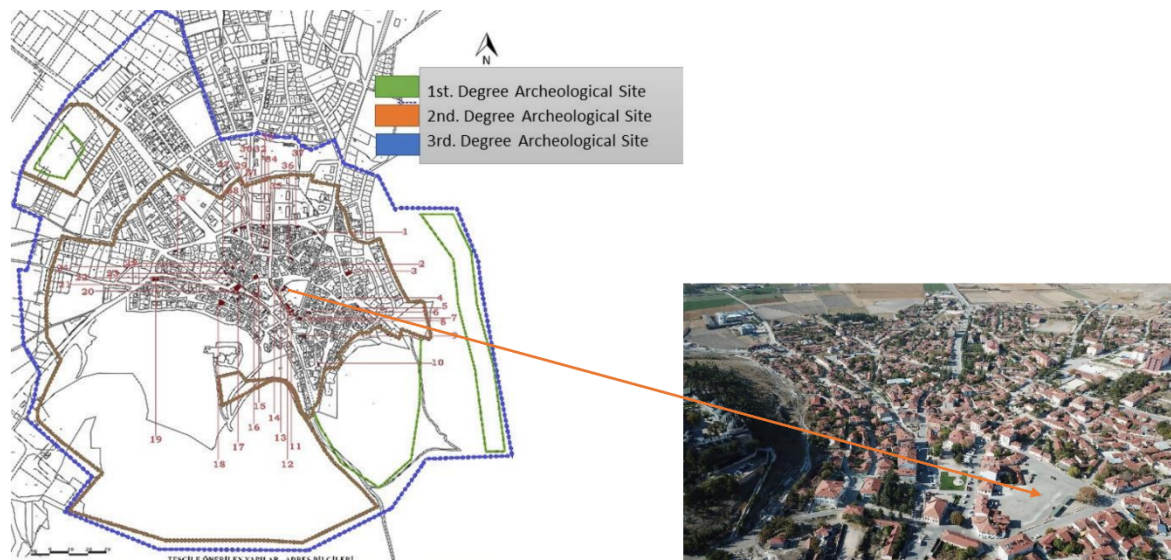
Figure 3. (Left) Seyitgazi District Site Boundaries and Qualified Traditional Civil Architecture Buildings Proposed for Registration (Right) Aerial View of the District Centre where Seyitgazi District Urban Fabric and Archaeological Site are Located.

As seen in Figure 3, the 1st-degree archaeological site area is the area bounded by the green legend known as Mesih castle in the south and east of the district and the region in the northwest. The region in the north-west is located where the district has developed in

industry. The 2nd-degree archaeological site is the region shown with brown legend, which includes the settlement area surrounding the district centre and many monumental buildings.

The 3rd degree archaeological site constitutes the area surrounding the 2nd degree archaeological site, indicated by the blue legend. As shown in the figure, the buildings marked with red legend within the archaeological sites are Anatolian-Turkish traditional civil architectural structures worthy of registration. It can be observed that the district has been able to preserve its archaeological cultural heritage as well as its urban fabric on a large scale together with its vital qualities.

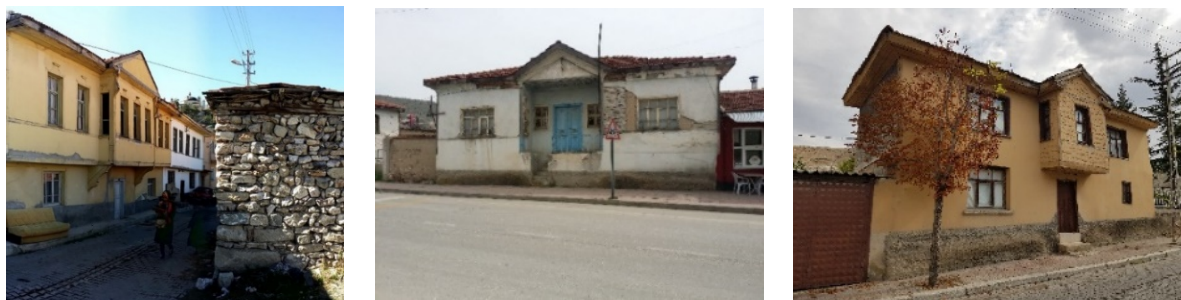
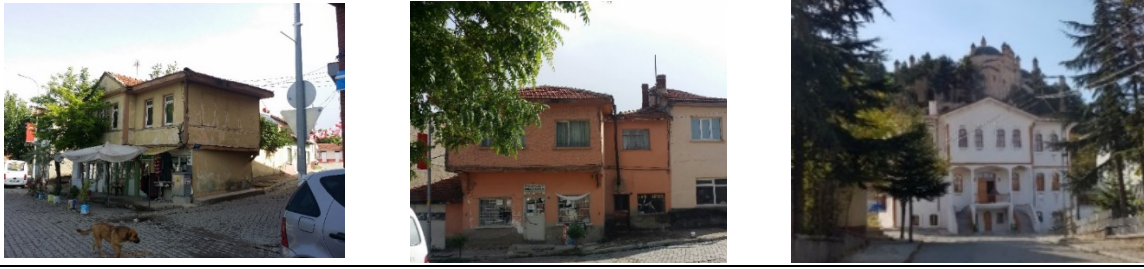
Table 1

*Examples of Civil Architecture Buildings in the Original Urban Fabric in Seyitgazi District (Elmas, 2020)*

The city has a multi-layered characteristic in terms of the civil architecture buildings that make up its structure (Table 1), the landscape in and around the city, the street silhouettes formed by these houses, the viewpoints and the historical environment, which have different degrees of importance in urban, rural and archaeological terms.

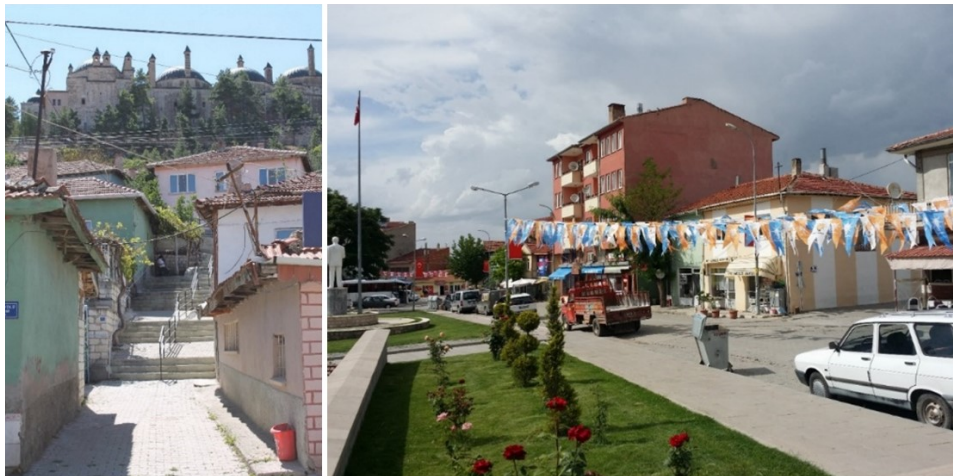
*Figure 5. Irregular Appearance of Seyitgazi Historical Environment.*

Under normal circumstances, the water element, which is important for urban landscaping, should not be a problem in the region, but these channels usually flow openly. Places closed by bridges or culverts can be opened over time. Animals drink from these channels, garbage and wastes accumulate there, and when the water overflows from time to time, the open areas pose a danger to people, animals and vehicles. Since it is located within an archaeological site, it is very difficult to make structural interventions (Sağıroğlu Demirci etc., 2020).

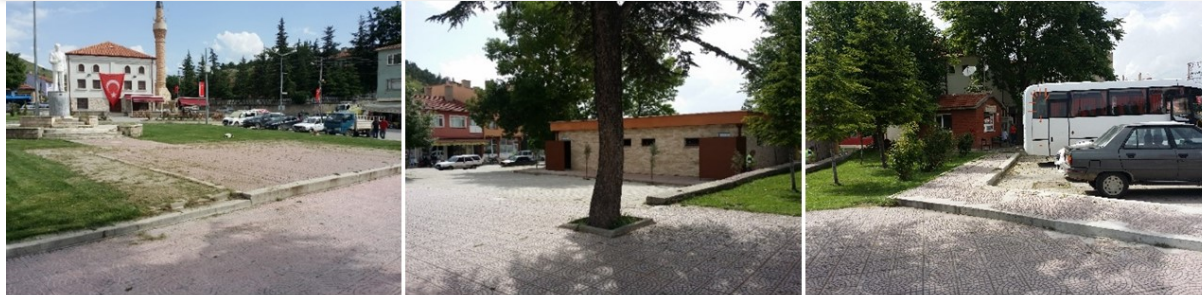
Figure 6. Irregular Parking Area in the Historical Environment and the WC Structure and Bus Terminal Built Later in the Square.

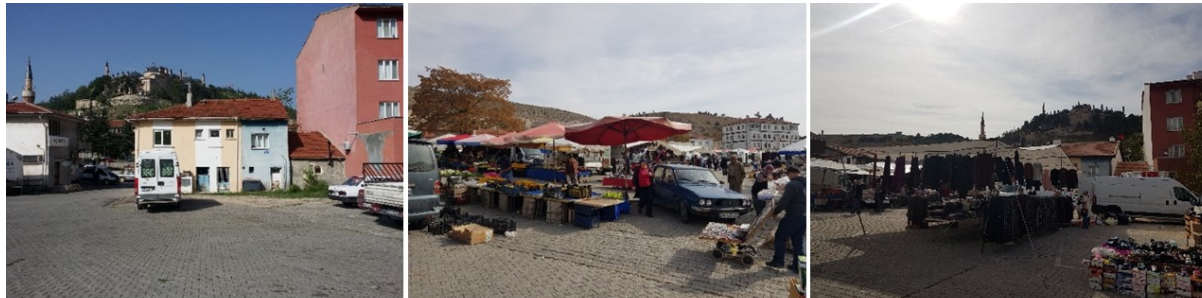
Figure 7. Market Place in the Historical Environment.

Since the arrangements that are important to be made within the urban site are largely not possible within the borders of the archaeological site, they result in images that are not fully preserved and improved. There is no stall arrangement set up for product sales throughout the market place. This situation causes a messy appearance. There is not enough space to meet the parking needs of the district center and traffic congestion occurs around the market place (Figure 7).

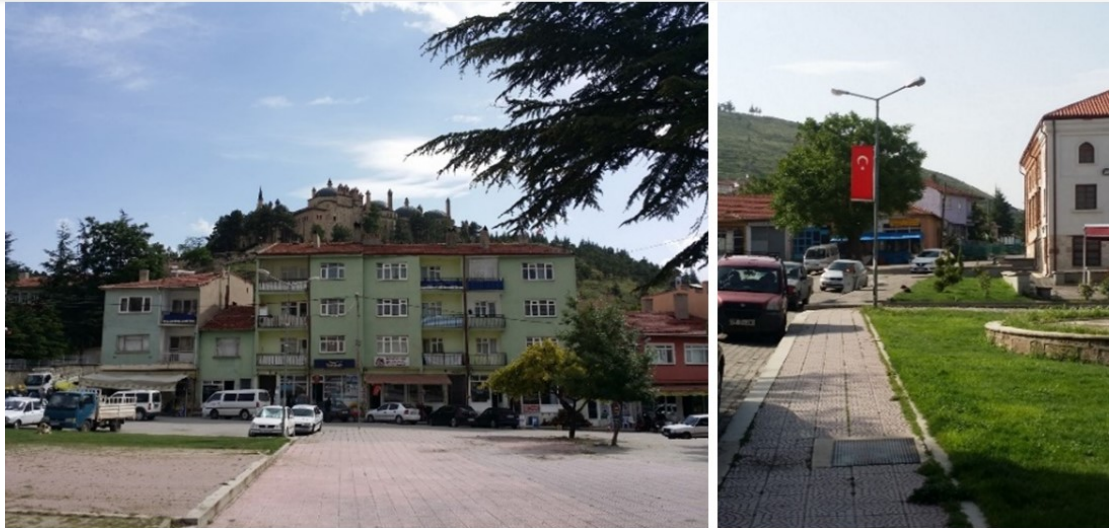
Figure 9. Seyitgazi Square with Changing Original Road Level.

The historical texture of the houses around the square, which continues to function as the most important open space and public space of the district, has changed with new structures over time. The original structures have either been replaced with new, unqualified reinforced concrete structures or left on their own without any awareness of protection, causing them to deteriorate and many of them to disappear. The local people's lack of awareness of protection has caused them to damage the cultural heritage structures they live in from inside and outside. Although these changes in the structures were stopped in 2012, the changes that took place until then have greatly damaged the original urban texture. Similarly, the changes made to the roads in the name of landscaping, and the continuous change and renewal of the road pavement material in the process that has come to the present day, have created a difference in elevation between the square and the surrounding roads, requiring high pavements. This has damaged the original transportation status of the square.

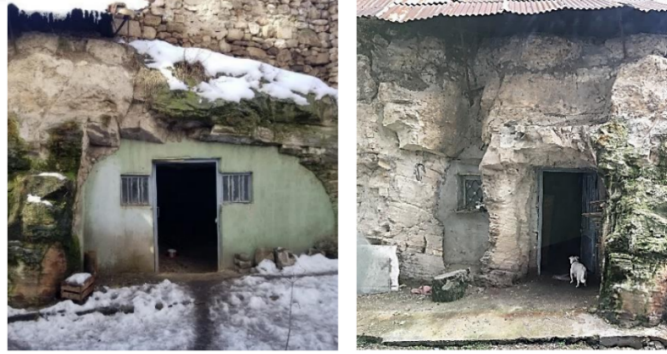
Figure 12. Rock Houses Behind the Buildings Facing the Street on Hamamyolu Street in Seyitgazi District.

The number of outbuildings built adjacent to the buildings or built with unqualified and harmful materials in a way to damage the building, as well as other structures built within the parcel is quite high. As a result of these practices, the original parcel texture is disrupted and unqualified construction has increased. The same situation is also valid for the rock houses in the district (Altınsoy, 2020: 7-8). These structures are the result of natural formation throughout the district. However, their unconscious use with damaging functions and materials such as warehouses, barns and corrals puts the heritage values of the settlement under risk and threat in terms of conservation (Figure 12).

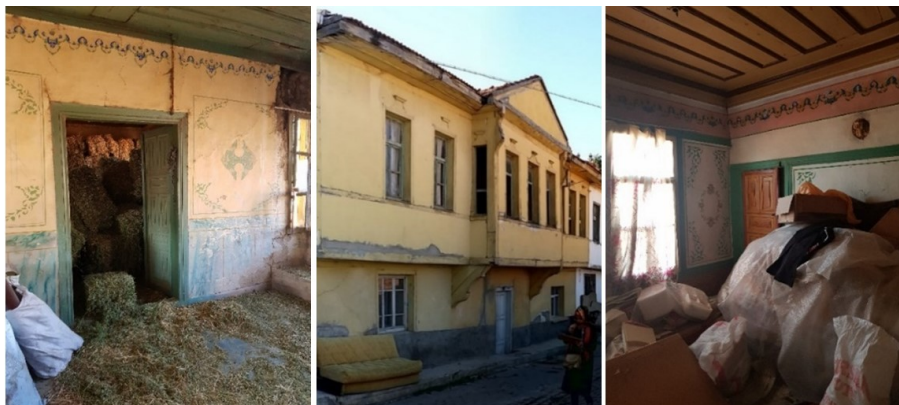
Figure 13. Kurtuluş Cad. 56 Block 3 Parcel Original Civil Architecture Structure.

The fact that rural architectural heritage and archaeological architectural heritage cannot be preserved together causes the continuity value of the settlement to be interrupted. The building shown in Figure 13 is one of the qualified civil architectural structures in the district, which has not been subjected to almost any intervention, even the hand-drawn patterns on the interior walls have survived to the present day, but has not been registered and repaired due to its location within the archaeological site. This building, like the other buildings, is among the abandoned buildings that have completed their physical life.

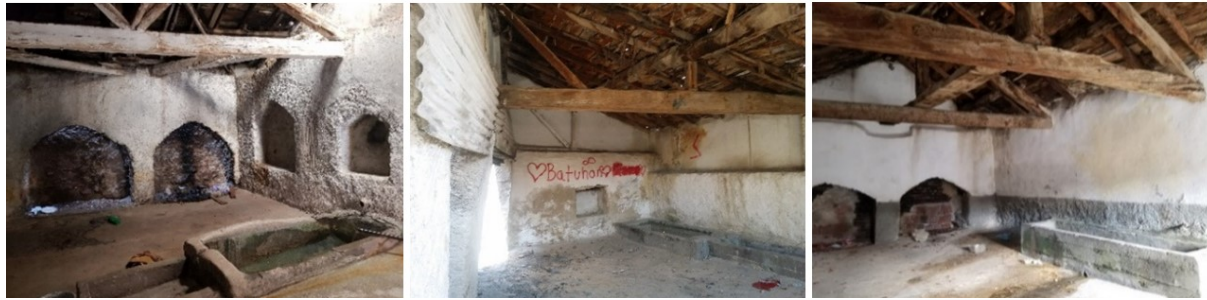
Figure 14. 'Sakana' Laundries in Seyitgazi District.

The situation encountered in the civil architectural structures in Seyitgazi is valid for the laundries known as 'sakana' by the local people, which are among the original structures of the district. These buildings were built for common use, their original function was laundry,

but they were also used by the local people for various activities and as a gathering place for women. Since they could not be registered, they could not be subjected to repair and restoration, and in time all but one of them lost their function.
