Effects of CNC Tool Runouts on Drilling Process

In this study, the surface roughness, dimensional accuracy and tool life that tool runout caused by CNC spindle mechanism based on metal mold manufacturing were investigated. In order to understand tool runout, spindle health measurement was performed: runout measurement with 300 mm test bar, spindle conical runout measurement, spindle pull force measurement and again spindle bearing vibration values were examined. In this study, spindle maintenance was performed and its effects on the final product before and after maintenance were investigated. Holes were drilled with 1, 2 and 3 times the drill diameter, the dimensional accuracy of the holes, the effect of runout on surface roughness in the hole drilling process and the runout and life of the drill bit used were investigated. The effects of runout before and after the maintenance were compared. Elimination of tool runout positively affected the surface roughness and parts with lower surface roughness were obtained. It positively affected the dimensional accuracy and the measurement tolerance was narrowed. Since the effect of tool runout on the cutting tool life is eliminated, its l

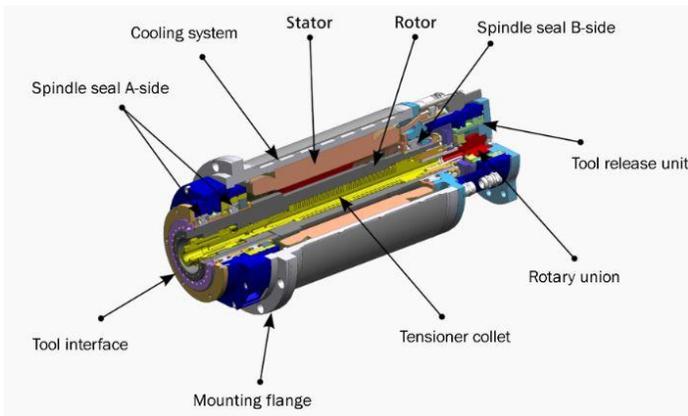
Figure 1. Appearance layout of CNC spindle parts [8]

Tool runout is triggered by not performing periodic maintenance of the cone, spindle bearings and drawbar springs that the tool is attached to on the spindle. These structures are shown in Figure 1. Periodic maintenance brings together many benefits such as production efficiency and longer use of the machine. [7].

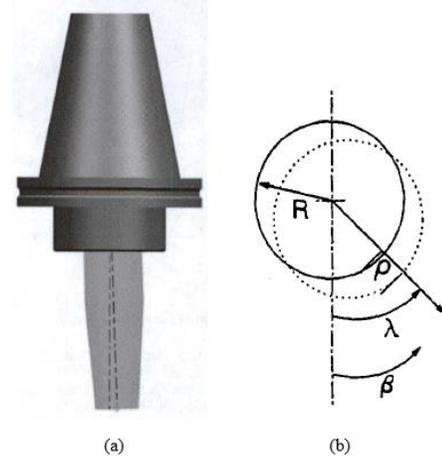
Figure 2. (a) cutting tool with axial run-out [13] (b) cutting tool path with radial run-out [14]

The cutting tool run-out occurs in two different ways, radial and axial (Figure 2). Tool run-out is a phenomenon that affects geometry accuracy in the cutting process and is neglected in most of the studies on tool path planning. A new approach is presented for integrating the cutter run-out effect into envelope surface modelling and toolpath optimization for five-axis side milling with a tapered cutter. The results show that geometry errors caused by run-out can be significantly reduced by using the proposed method [13].

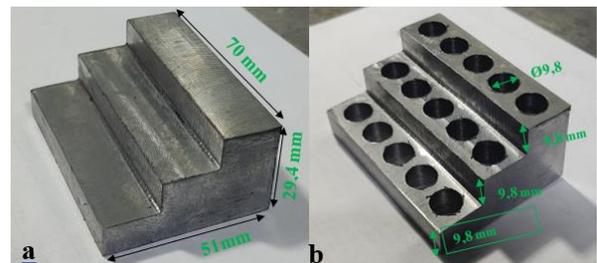
Figure 3. (a) Non-drilled test apparatus (b) Drilled test apparatus (Material SAE 1020)

Drilling processes during the experimental study are shown in Figure 3 and Figure 4. Again, the tools and holders used during the work are shown in Figure 5. The wear of the drills used by the runout effect was investigated.

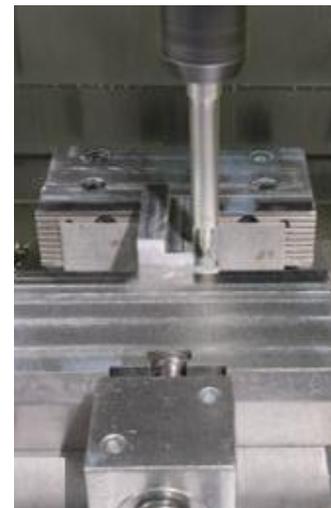
Figure 4. Drilling operation of the test apparatus

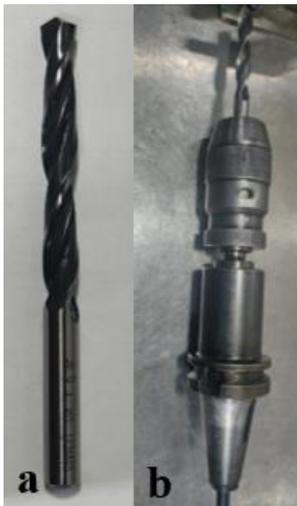
Figure 5. (a) HSS drill Ø 9.8 mm (b) Ball holder and drill

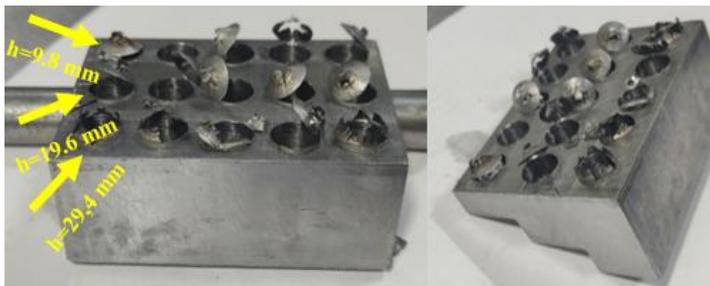
Figure 6. Burr formation that occurs according to the hole length that occurs in the drilled hole operation when there is tool run-out on the machine.

For lengths of 1, 2, and 3 times the drill diameter, pictures of the holes drilled before maintenance and with tool run-out are given in Figure 6. Drilling operations performed by removing tool runouts after maintenance are given in Figure 7. As the hole length increased in the holes drilled while the machine was run-out and not maintained, the burr structures formed in the hole also changed; burr images are given in Figure 7. As the hole length increases, the amount of burrs and burn marks due to overheating are observed in the metal.

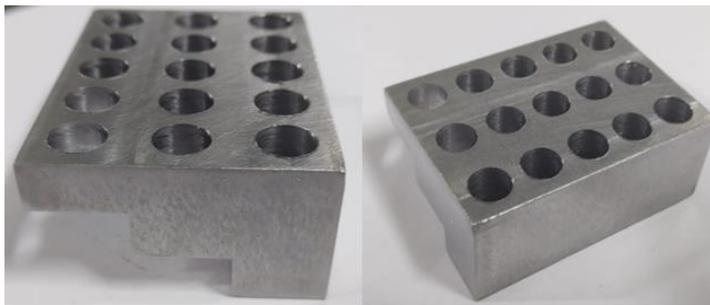
Figure 7. Hole exit images of drilled holes without tool runout after maintenance

After the maintenance, no significant burrs and burn marks were found at the hole exit points. No differences were observed

in the holes according to the hole sizes. The structure of the holes resulted in the desired levels and in accordance with the production after the maintenance.

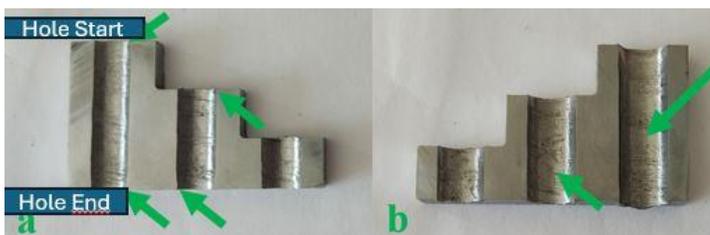
Figure 8. Drilling operation before maintenance; (a) Diameter changes at the top and bottom of the hole (b) Rough surfaces on the hole surface

Due to the length of the hole, two measurements were taken from the hole with a length of $h = 19.6$ mm and a single measurement was taken from the hole with a length of $h = 9.8$ mm so that the surface roughness device could make a valid measurement. The surface roughness of the holes and the narrowing of the diameter from the top of the hole to the bottom can be seen in Figure 8.

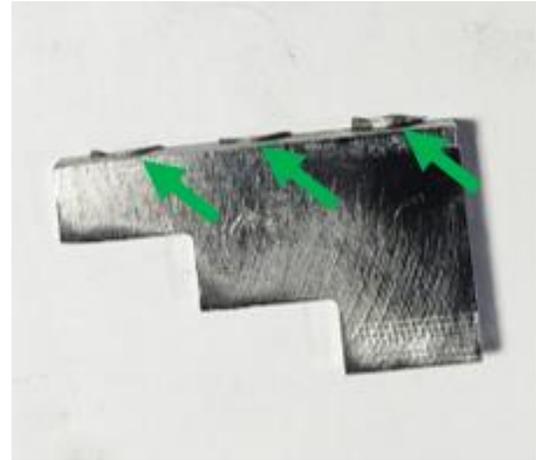
Figure 9. Hole burr formation due to hole length when tool run-out is present before maintenance

The formation of the burr height that occurs during drilling when the tool is run-out due to the increase in the hole length can be seen in Figure 9. It was observed that the amount of burr at the bottom of the hole increased as the hole length increased. It is compared with the amount of burr formed after maintenance. Burr formation creates the need for more hand levelling and deburring operations. After the maintenance, no shrinkage or burr formation was observed in the hole.
