Title: Sustainable Maintenance Strategy for Wood Windows Defects

Sustainable Maintenance Strategy for Wood Windows Defects

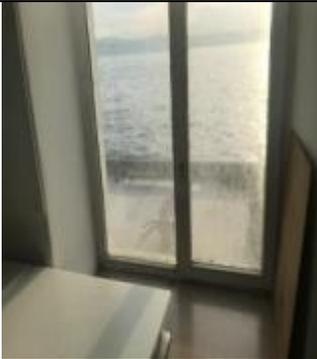
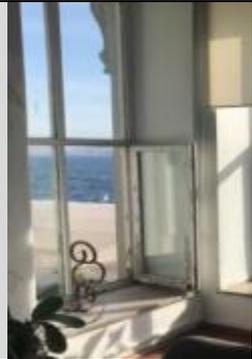
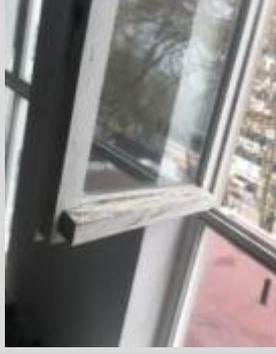
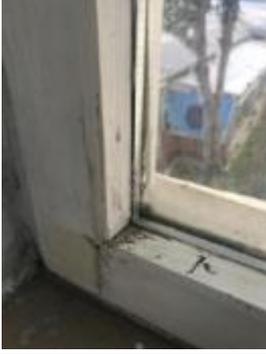
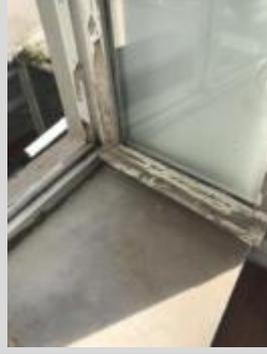
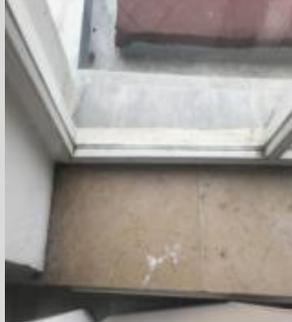
Table 13. Photographs for information on the status of windows according to defects

2nd Degree Damaged Windows (P37 Code Window)	3rd Degree Damaged Windows (P5 Code Window)	4th Degree Damaged Windows (Window P13 Code)	5th Degree Damaged Windows (Window P26 Code)
There is no 1 st degree damaged window

There was also heat loss on the glass surface. It was also found that there was a gap, mold, and wear of the silicones between the frame-wall, the frame-lintel, and the frame-windowsill. 90% of these damages occurred due to design and environmental conditions. In the design, placing the window frames on the outer surface of the wall caused them to remain unprotected and hence, be exposed to severe environmental conditions directly.

It was found that the deteriorations on the façade of the building facing the sea were more severe and the deteriorations were observed on the lower frame and planted drip. As for the level of deterioration where decay was observed, the lower part of the sash fell and the window

became unusable (Table 12-13). The sash must be replaced. Again, 95% of the windows in this direction showed intense blistering on the outer surfaces. For this reason, the amount of deterioration was high. Intense cracking and crevices were found on the exterior. Breaks and disintegration were also observed in glass laths. Depending on the cross-section, the heat permeability level was quite high. The glass cannot be changed as the cross section cannot be increased.

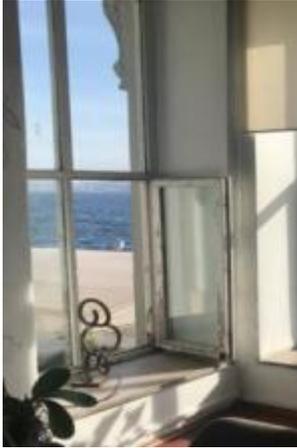
Table 16. Control List

In the study, the most appropriate maintenance and repair planning were made for the window system with the damage degree code of P13 among the 62 window systems examined. The most important damage detected in this window system is the presence of decay in the casing and cracks in the sash. The criteria were determined according to the rate of deterioration of the window. Maintenance planning has been subjected to general preliminary assessment in terms of heat impermeability, water impermeability, durability aesthetics, and cost criteria. In terms of heat impermeability, it was observed that there were leaks from these points where the strip on the edges of the window sash were worn. Heat transitions have been detected on the areas where the frame and sash connect, which caused swelling of the plaster and paint between the wall and the frame. When the water impermeability was examined, it was observed that the gutters made to prevent the ingress of water into the frame were blocked, and the frame was found to be rotting from the cracks caused by both water and sun rays. In terms of aesthetics, there is intense visual deterioration especially on the exterior surface with the rotting of the frame and sash. Decay was seen as critical damage in the examined window systems, and it was found that the sub-head of the sash was broken, and the sash could not perform its function. The second critical defect that occurred due to decay was spillage and cracking of the wooden frame, sash and glass laths. The common defect observed in almost all windows was the application of very thick paint on the surface, and swelling, as well as spilling of this thick paint layer depending on the environmental conditions, which means that the wood remained unprotected.

General Information about Building	Kod: P13	Name of Building: Historical Education Building
